DRAFT
Geology: Existing Condition and Environmental Consequences
Turkey Cove Vegetation Management Project
Lee County
Clinch Ranger District
George Washington & Jefferson National Forests
Prepared by: Thomas Collins, Forest Geologist
October 1, 2018

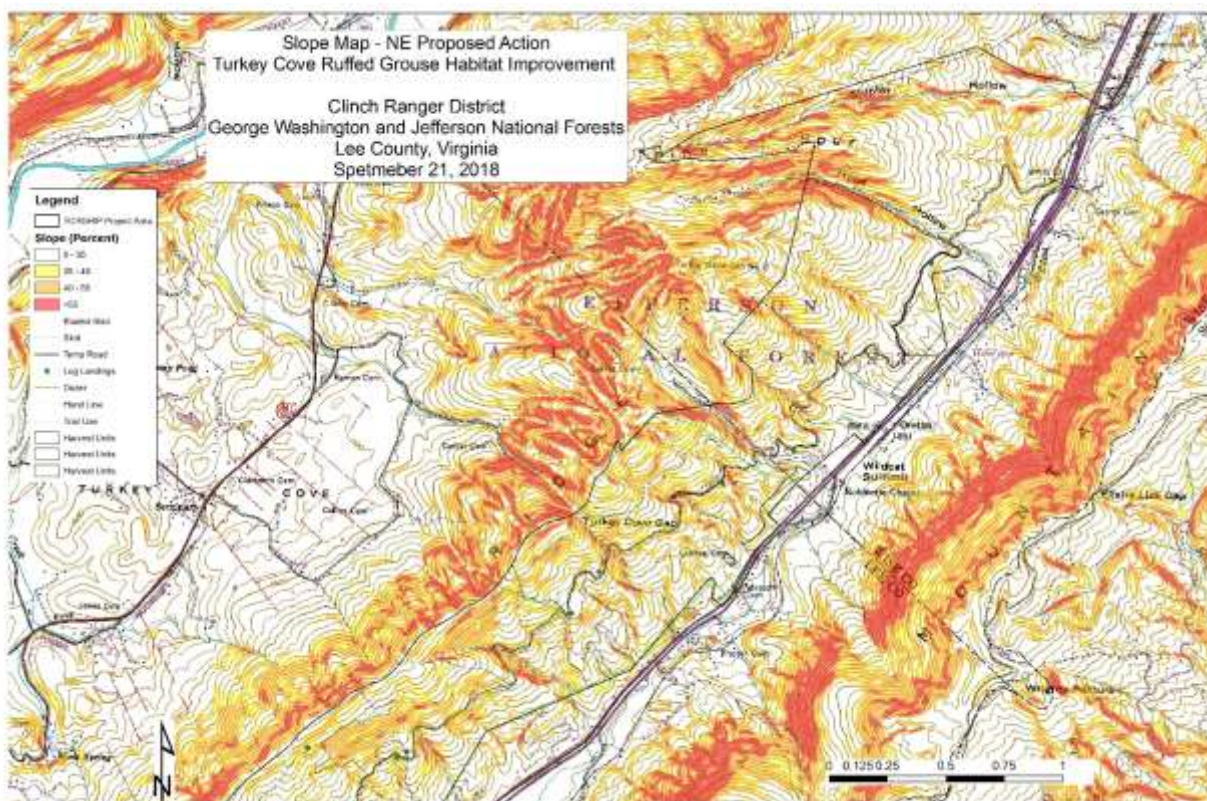
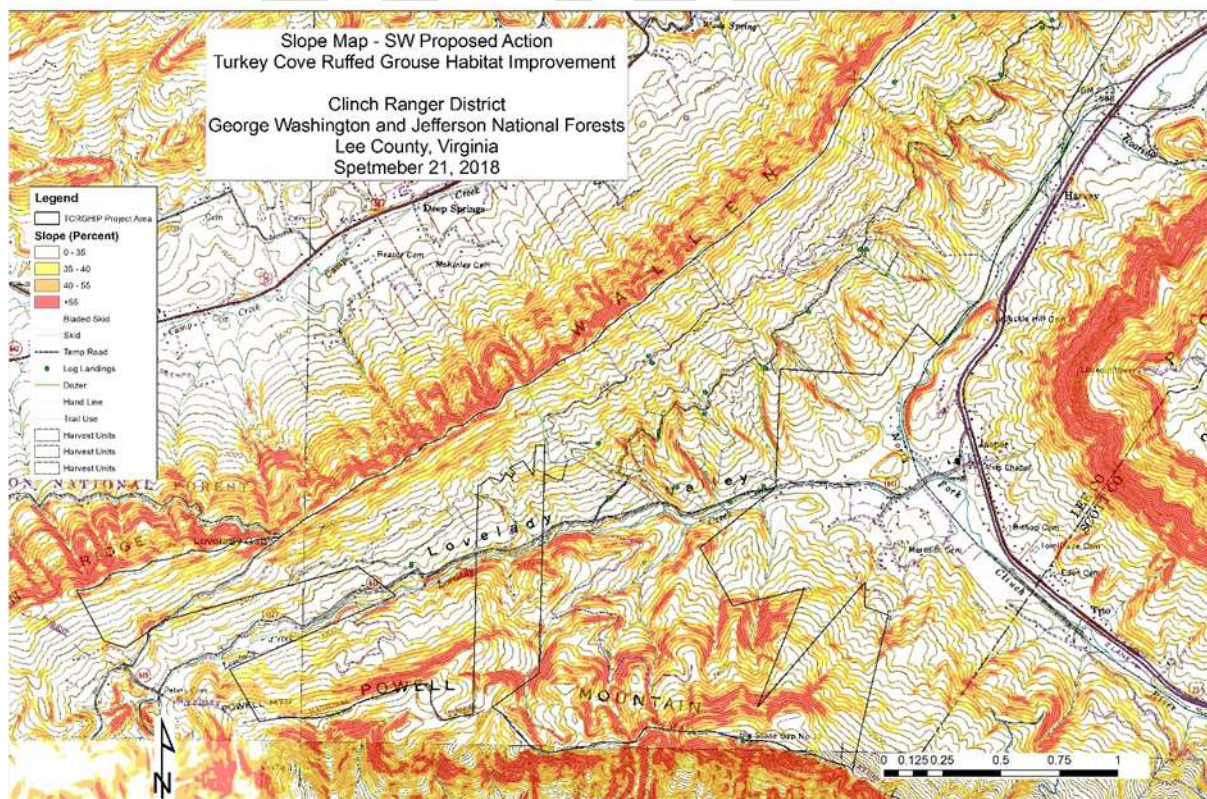
One overarching factor and driver of potential impacts on slope stability is the steepness of the slopes where project activities would occur. Slope gradient (%) will be used as an indicator of potential for project activities to alter conditions affecting slope stability. The slopes in the southwest and northeast part of the project area are shown on two maps with slope % classification: 0--35, 35-40, 40-55, +55 (Slope Map – SW Proposed Action and Slope Map – NE Proposed Action).

The north slope of Powell Mountain has a concentration of slopes steeper than 35% within the project area. But the proposed action is on the southeast slope of Wallen Ridge, and not on the north slope of Powell Mountain. The Wallen Ridge part of the project area has slopes steeper than 35% dispersed among the slopes less than 35% along the broad southeast flank of Wallen Ridge, with the steepest slopes along the incised drainages (hollows).
